PORT OF FLEETWOOD

NOTICE to MARINERS 1 of 2021 Channel constant

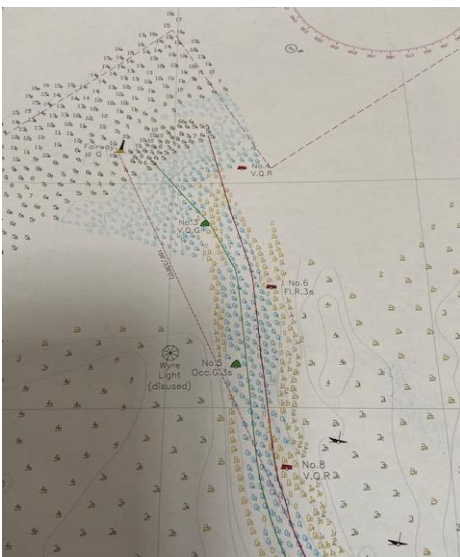
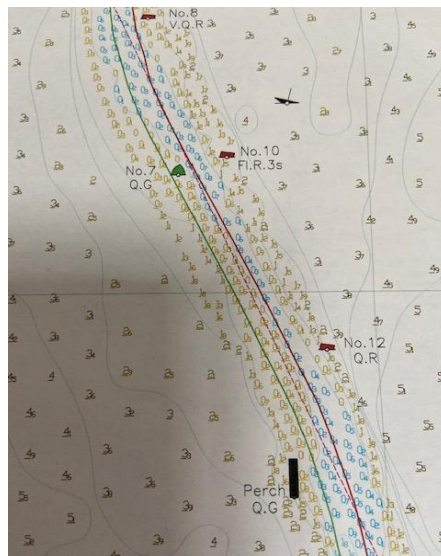
Mariners are hereby advised that following survey the controlling depth for the Fleetwood Channel between the Fairway and No.20 buoys lays in the vicinity of the No. 3 buoy and No 4 buoy where the channel dries up to 0.5m above Chart Datum and No7 and the Perch where the channel dries up to 0.9m above chart datum.

The remainder of the Fleetwood and Dock Channels are currently drying to various heights; **Mariners are advised** to consult the latest soundings chart outside the Marina office. These depths are only valid at the time of survey and are liable to variation due to siltation.

Mariners are requested to ensure that they allow a safe under keel clearance, appropriate to their vessel, especially when navigating over the low water periods.
